Technical Report 76

EFFECTS OF HURRICANE CAMILLE  
ON THE LANDSCAPE OF THE BRETON-CHANDELEUR ISLAND CHAIN  
AND THE EASTERN PORTION OF THE LOWER MISSISSIPPI DELTA

Reprinted from Coastal Studies Bulletin No. 4

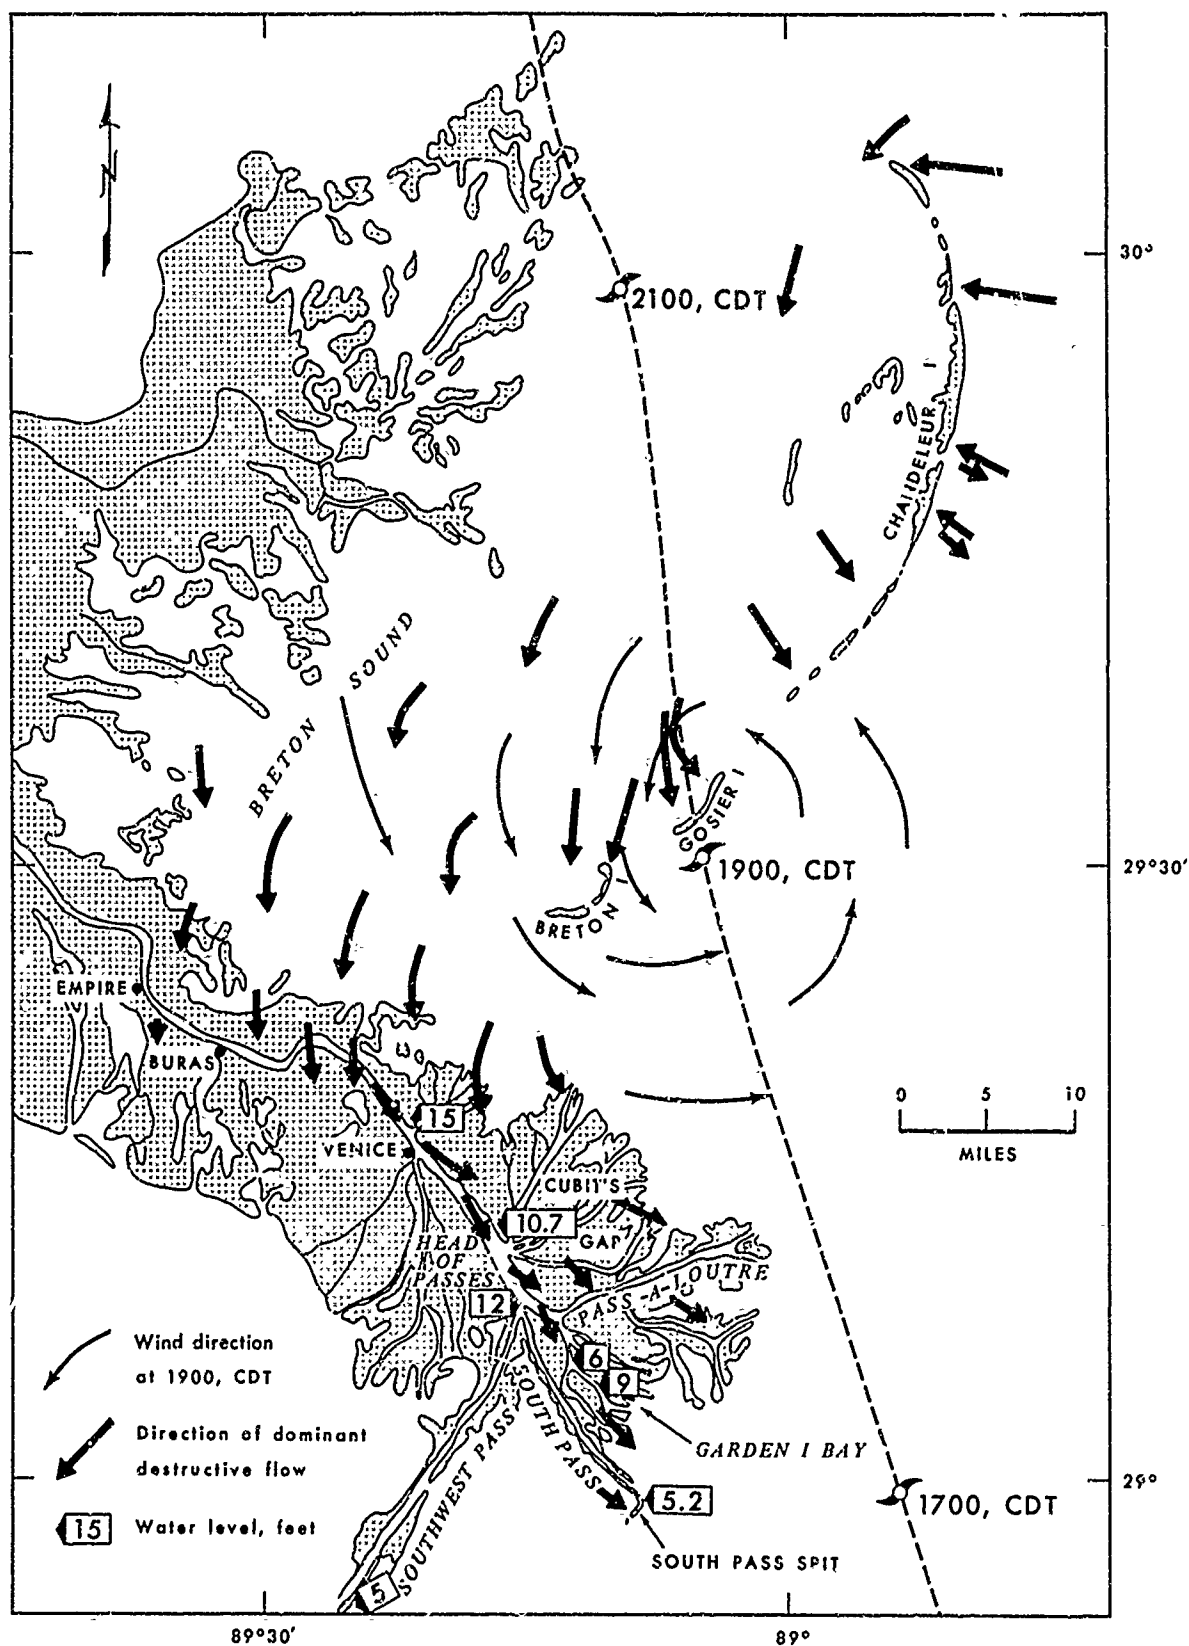
Figure 1. Index map; dominant surge currents; maximum observed and estimated water levels.

Aerial and ground reconnaissance indicate that wind velocities over 100 miles per hour moved a massive, swiftly flowing surge generally southeastward across the marshes east of the Mississippi River in the lower delta. Buildings, trees, debris lines, flotsam, and patterns of flattened marsh vegetation indicate this general trend (Fig. 1).

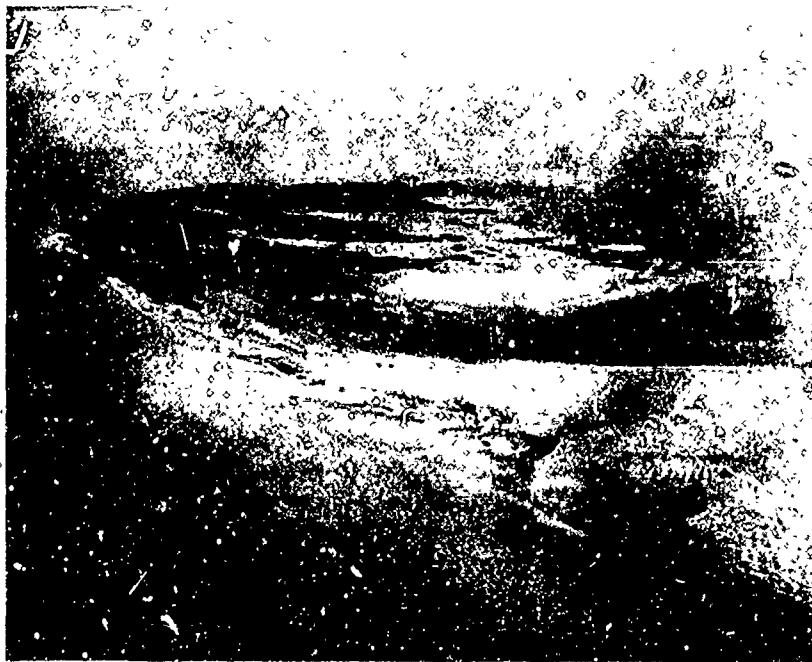
On the northern part of Breton Island, a crescentic recurve convex to the north, the situation was somewhat more complex, and vestiges of bidirectional transport are apparent. Figure 5 shows this area after the passage of Camille. The large patch of sand on the north side of the circular structure was absent prior to the storm; it appears to owe its existence to washover from the beach which formerly fringed the island's northern side. Such washover could be attributable to flow directed to the

southeast (i.e., return flow) or to onshore waves refracted around the northern tip of the island. The sand waves and partially submerged sand plumes in the lower right-hand corner are indicative of flow in the opposite direction. If features as sensitive as the latter had been formed by the initial surge, they would surely have been obliterated by the return flow. They could be associated with a secondary surge (or resurge) such as that postulated by Redfield and Miller (1957) or with conventional tidal flow following the hurricane.

Figure 5. Breton Island; northern end, sound in foreground.

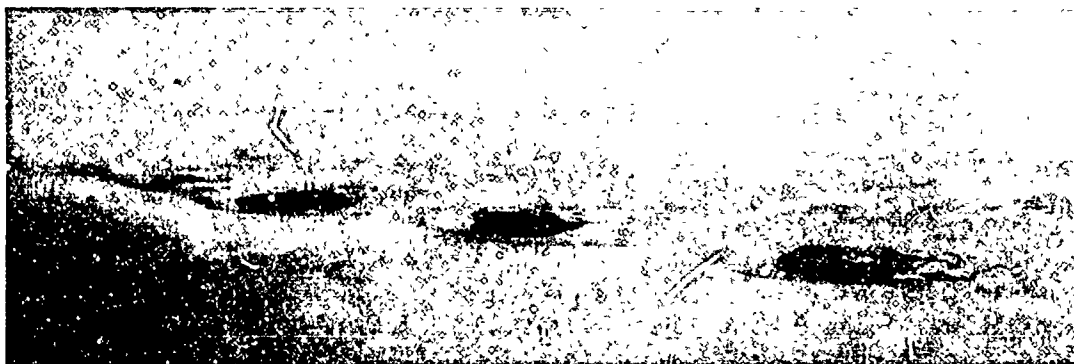
The severe destruction wrought by Camille is immediately evident from Figure 6. Except for five small subaerial patches, the island has

Figure 6. Gosier Island; sound side in foreground.

been reduced to a broad shoal. Figure 6 is oriented facing seaward, and it is interesting to note that nearly all the sediment has accumulated on the seaward (right) side of the residual islands, in spite of Gosier's situation in the hurricane's right semicircle. It is, of course, reasonable to assume that high onshore waves and surge components were significant in destroying the beach and effecting the dissection. However, it is apparent that any patterns inherited from the initial surge have been completely superseded by transport associated with the final event (return flow).

The pattern of dissection of Gosier Island seems to have been influenced to a large degree by the patterns of tidal channels and marsh segmentation which existed prior to the storm. Though it is not clearly evident from Figure 6, the residual islands tend for the most part to be triangular, with their apexes pointing southward. This corresponds to the shape of the marsh segments which existed previously. It would appear that flow and resultant erosion were channelized and were most strongly concentrated in the tidal channels and small embayments which originally crenulated the soundward side of the island.

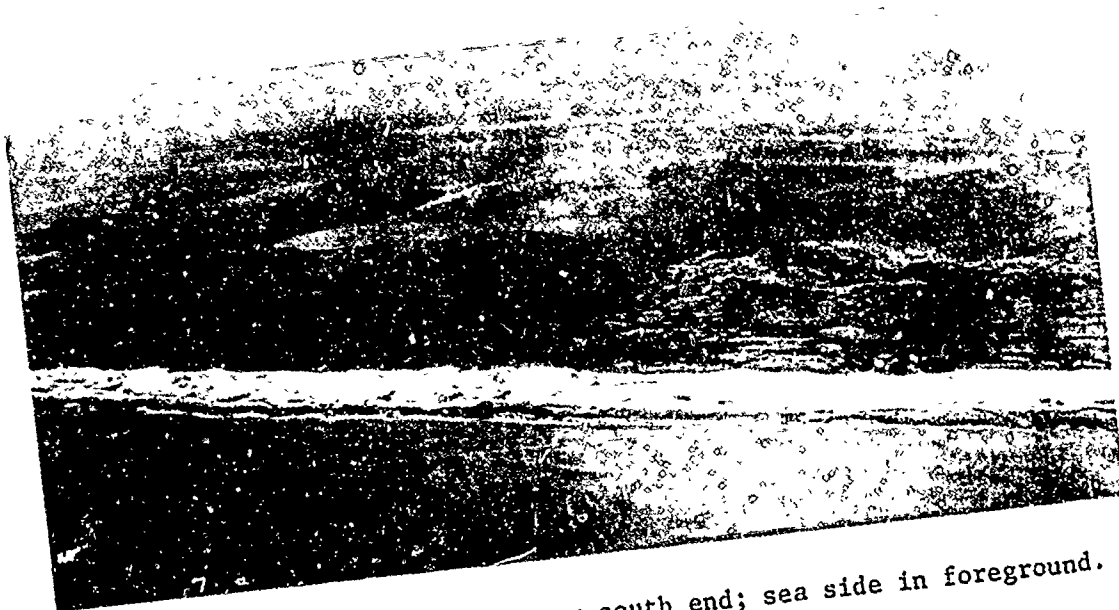
The shallowness and small volume of the beach along the Chandeleurs undoubtedly favored its obliteration, and, as might be expected, beach erosion was more complete at the southern end of the Chandeleurs than on Breton Island, which was several miles closer to the eye of the storm. Removal of sands was probably further enhanced by the numerous inlets which could have served to concentrate flow. Thus, at the southern end of the island chain only the tenacious marsh deposits survived to render subaerial expression following Camille.

Figure 7. Chandeleur Islands, near south end; sea side in foreground.

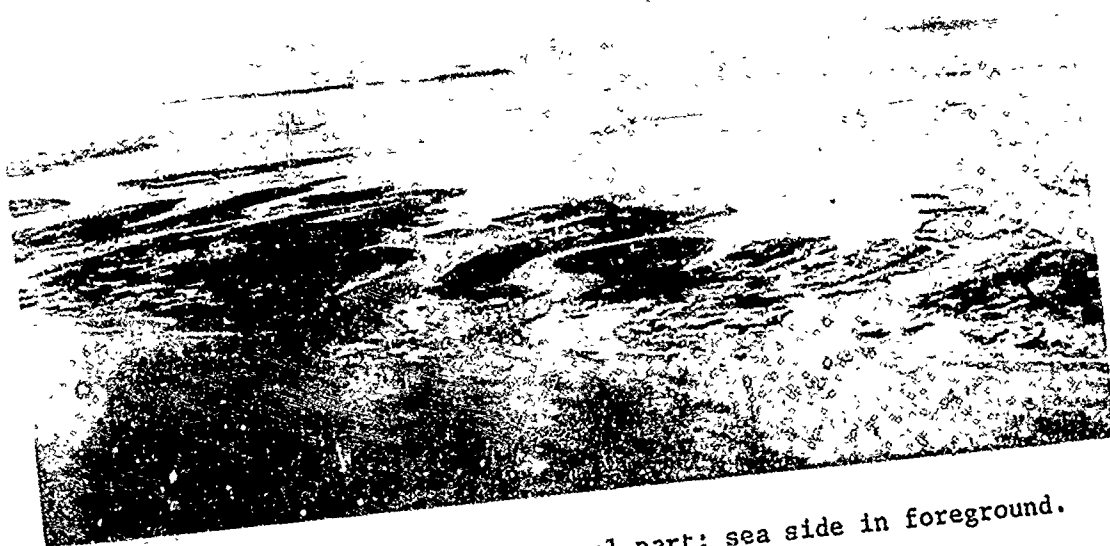
Northward along the arc there is an increase in the amount of sand remaining near or above the water surface, but this is mainly in the form of shoals on either side of the remaining land surface and very thin sheets scattered over the marsh. In the vicinity of Figure 7, about 3 miles north of the southern end of the Chandeleur chain where the island attains its maximum width, the sand has been pushed a short distance landward, and a strip of relict marsh along the seaward margins has been exhumed; but the coastline has apparently resisted dissection and severe erosion. Here the greater width of the marsh probably absorbed much of the energy of the return flow.

Figure 8. Chandeleur Islands, central part; sea side in foreground.

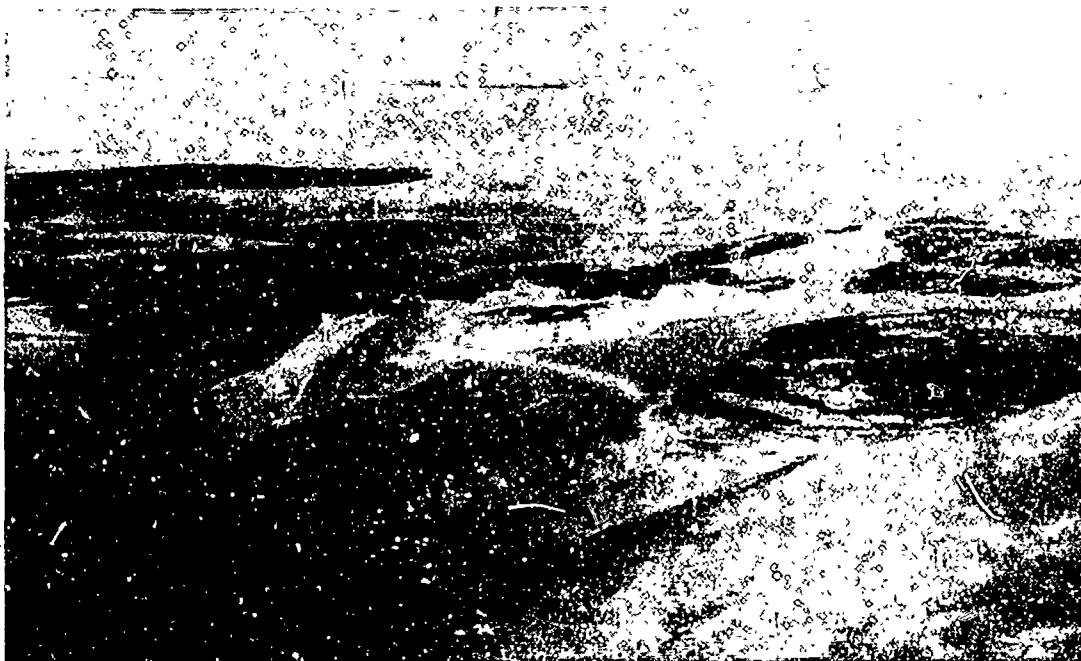
Still farther north, in the central portion of the island, dissection again prevails. Pre-Camille photographs (April 1969) indicate an unbroken stretch of beach, but there are numerous tidal channels through the marsh and mangroves behind it. For the most part these channels were aligned transverse to the trend of the island and terminated abruptly at the backshore of the beach. It is clear from Figure 8 that the channels have dominated in controlling dissection patterns. The beach, which formerly had a width here of about 50 feet, was for the most part completely eroded. Figure 8 suggests that most of the beach sand accumulated as shoals on the sound side of the island. It was also evident from color slides and visual observations that a thin film of sand covered most of the marsh area. This trend is, of course, in contrast to those observed farther to the southwest, around Breton, Gosier, and southern Chandeleur islands, and implies a less consequential role for return flow. Figure 9, taken 1 mile north of Figure 8, shows definite but small-scale seaward transport. In this particular case, seaward transport is apparently a secondary effect and may simply indicate that final breaching did not occur until water level in the sound was falling. Certainly, soundward transport was dominant in the vicinity, as the photograph of the area adjacent, to the north (Fig. 10), demonstrates.

Figure 9. Chandeleur Islands, central part; sea side in foreground.

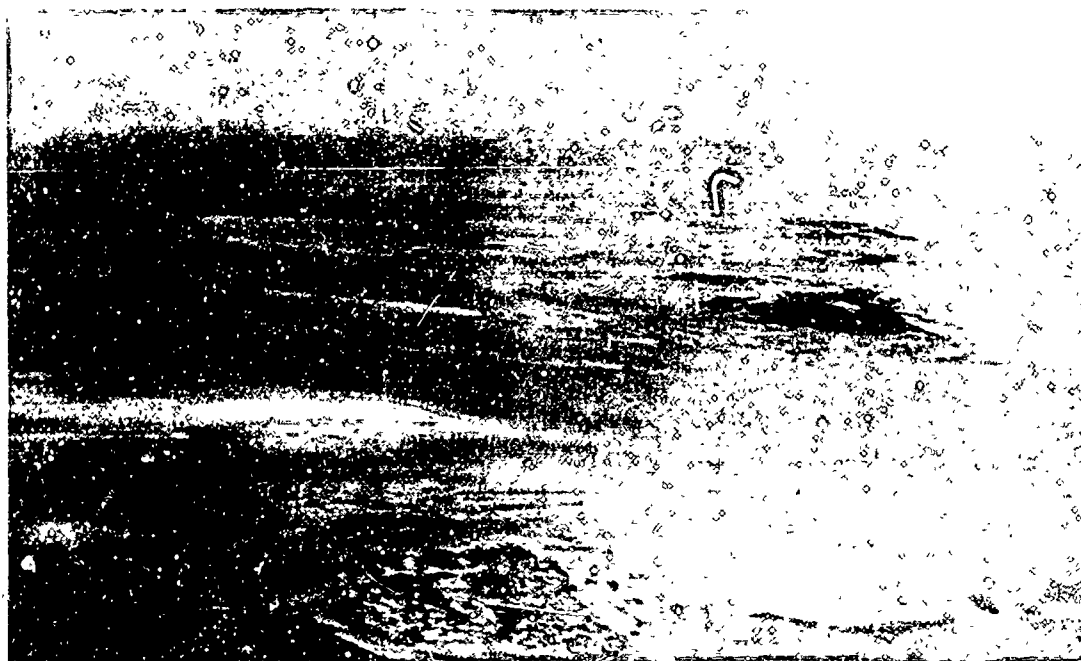
Figure 10. Chandeleur Islands, central part; sound side to the left.

erosion on Chandeleur Island took place along a 1.5 - 2 mile section 10 miles south of the northern tip. Figure 10 is oriented facing north along this section. All that remains above the high-tide surface are a few small patches of mangrove and marsh. Again, the prehurricane topography appears to have exerted the major control. Prior to Camille, large washover fans of beach sand buried the greater portion of the marsh and extended across the entire width of the island. Consequently, the storm was able to erode and redistribute the mobile, unstabilized sands without hindrance from more resistant marsh or mangroves. Though sand has been deposited predominantly on the sound side of the island, locally there is evidence of seaward transport. Overall, the shallow shoals which now comprise the greater portion of the area are reminiscent of sand flats in areas of high tidal range, where there is strong bidirectional flow. Of course, the area in question is one of comparatively low tidal range, but in this area hurricane surge and return flow may have attained a balance that produced a tidelike effect.

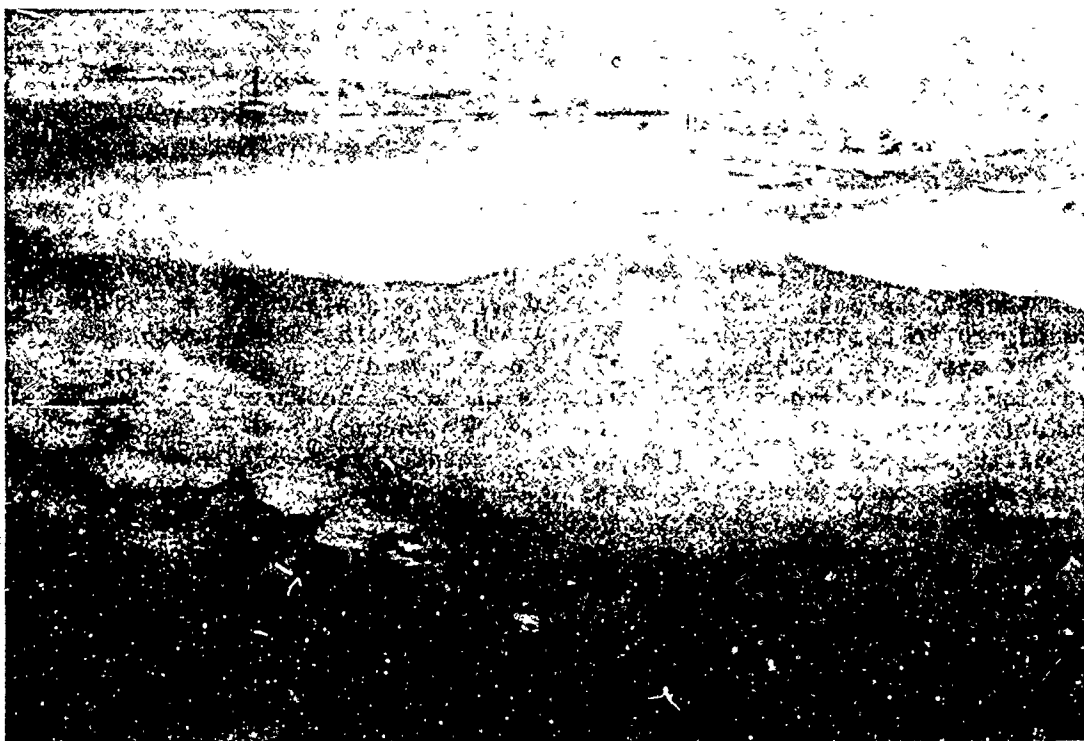
The northern 8 miles of Chandeleur Island formerly consisted of an unbroken sand beach 250 feet wide which was backed intermittently by mangroves. As elsewhere in the chain, erosion and dissection were significant. However, beach removal was much less complete, and moderately wide strips of beach remained intact except where a breach occurred. Breaches were relatively narrow and, again, seem to have occupied previously existing tidal channels. Eroded sediments were deposited entirely in the lee of the island, as Figure 11, which shows the extreme northern end of the island around Chandeleur Light, suggests. Sand washed through breaches by the surge accumulated immediately soundward of the breach in spectacular fan-shaped deposits.

Figure 11. Chandeleur Islands, north end; sound side to the left.

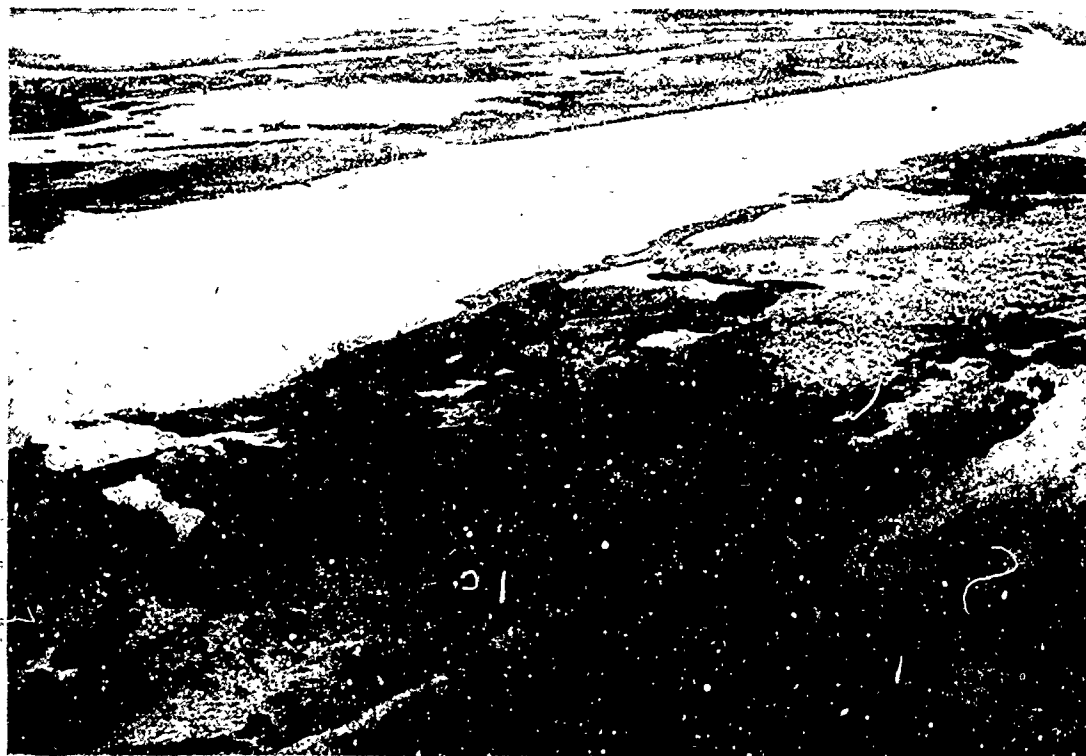
Severe damage occurred from floodwater currents and winds to the extensive stand of Phragmites communis (Roseau cane) along Pass a Loutre, South Pass, and within the Cubits Gap and Garden Island Bay subdeltas. Phragmites typically grows to heights of 8 to 12 feet in dense stands whose form would offer high resistance to winds and flowing water (Chamberlain, 1959). Entire stands were flattened and leaves were stripped, so that brown stalks (culms) were exposed (Fig. 12). Dead stalks of the previous years' growth were broken and removed by the high winds and water. Great masses of this debris were observed floating in the Gulf of Mexico around the margins of the delta (Fig. 13).

Figure 12. South Pass; flattened Roseau toward channel; erect fringe of Roseau in foreground.

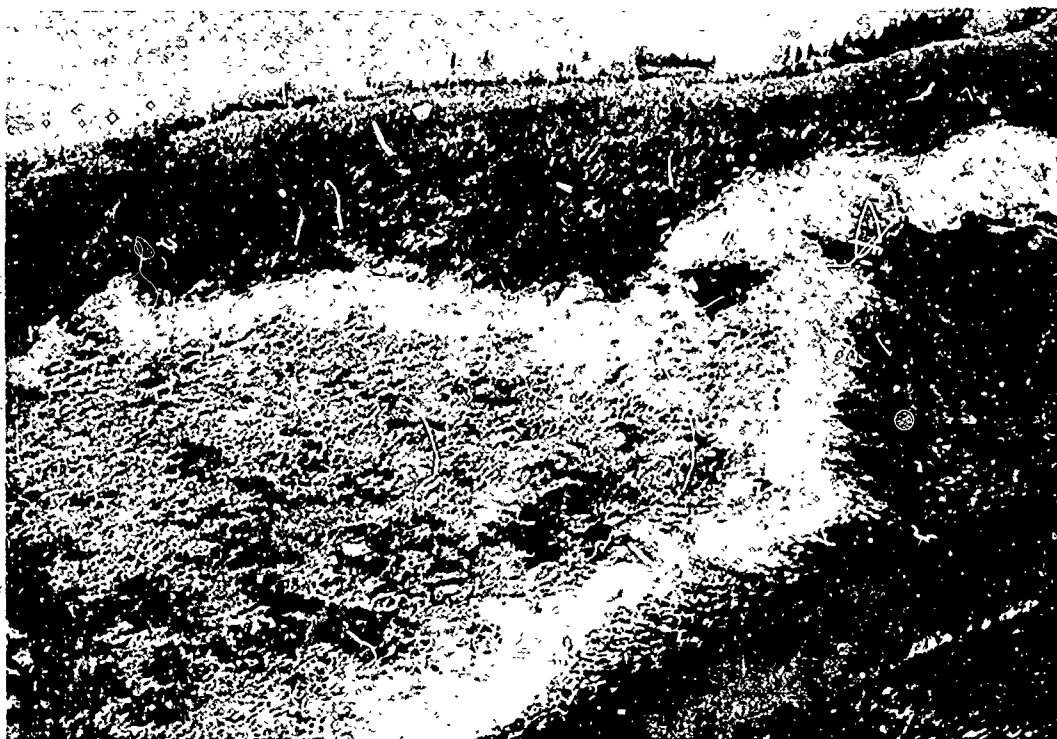
Commonly, the Phragmites stands were twisted and flattened in tortuous patterns (Fig. 14). As the hurricane floodwaters receded, these distorted stands trapped large quantities of floating organic debris and trash.

Figure 14. South Pass; patterns in Roseau debris.

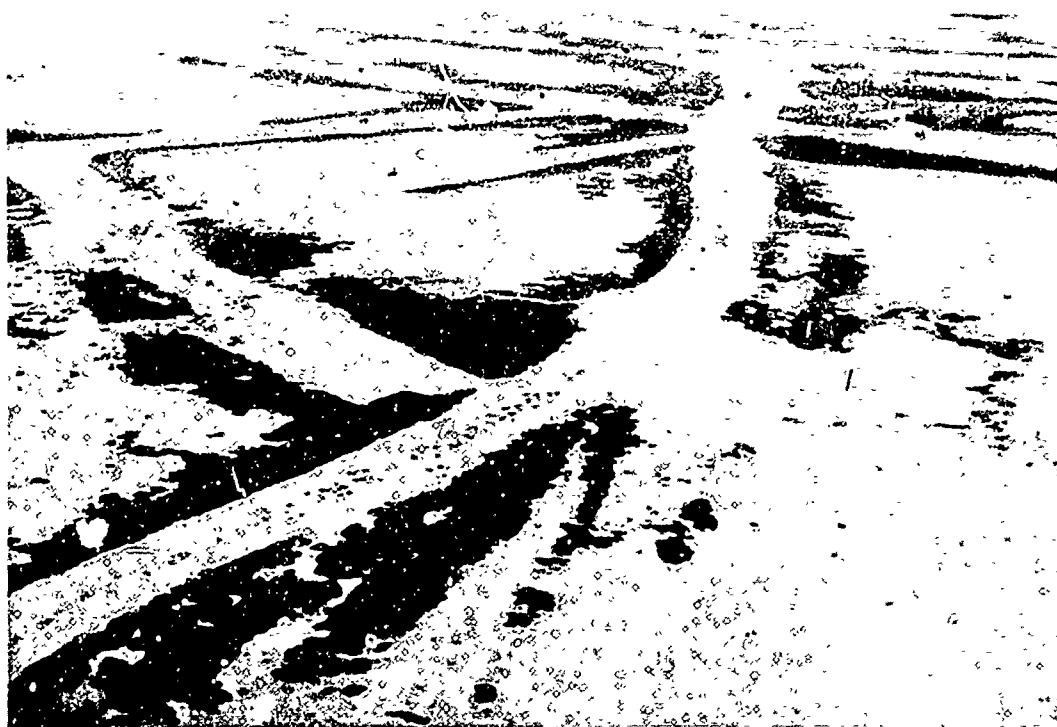
Wave action, inundation, and subsequent receding waters removed most of the floating aquatic vegetation from the ponds and bays. Large patches of alligator weed (Alternanthera ramosissima) and water hyacinth (Eichhornia crassipes) were observed floating seaward in distributary channels and canals (Fig. 15).

Figure 15. Garden Island Bay; floating aquatic vegetation moving seaward.
